1st Avenue: River Road to Grant Road

Virtual Open House 10/10/2024

Project Overview

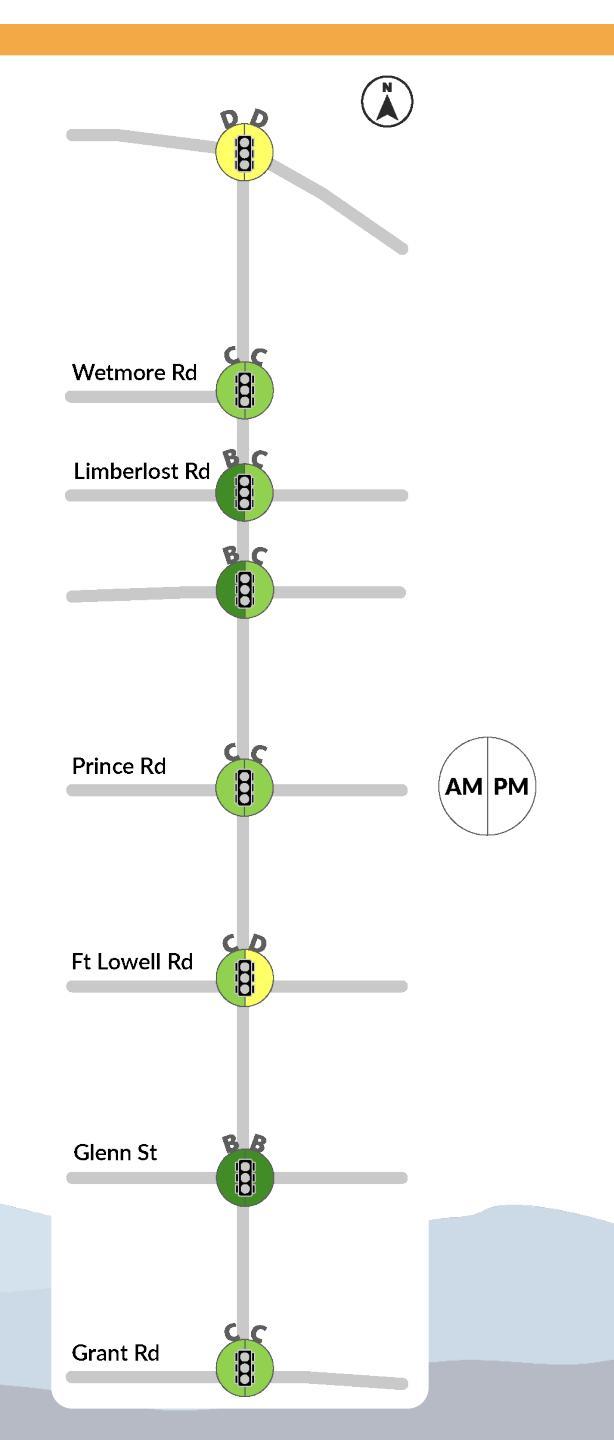
Current Conditions: Traffic

The map highlights the intersection Level of Service, or how long cars wait at an intersection. Most of the day, vehicles travel through the corridor with very little delay.

- Very low delay and most vehicles do not stop.
- Low delay and some vehicles stop.
- Moderate delay and a significant number of vehicles stop.
- The limit of acceptable delay in an urban area; many vehicles stop and some in the queue may not make it through in one cycle.
- High delay with poor progression; Most vehicles will not make it through in one cycle.
- Unacceptable delay; Demand exceeds intersection capacity. Many vehicles require two or more cycles to make it through.

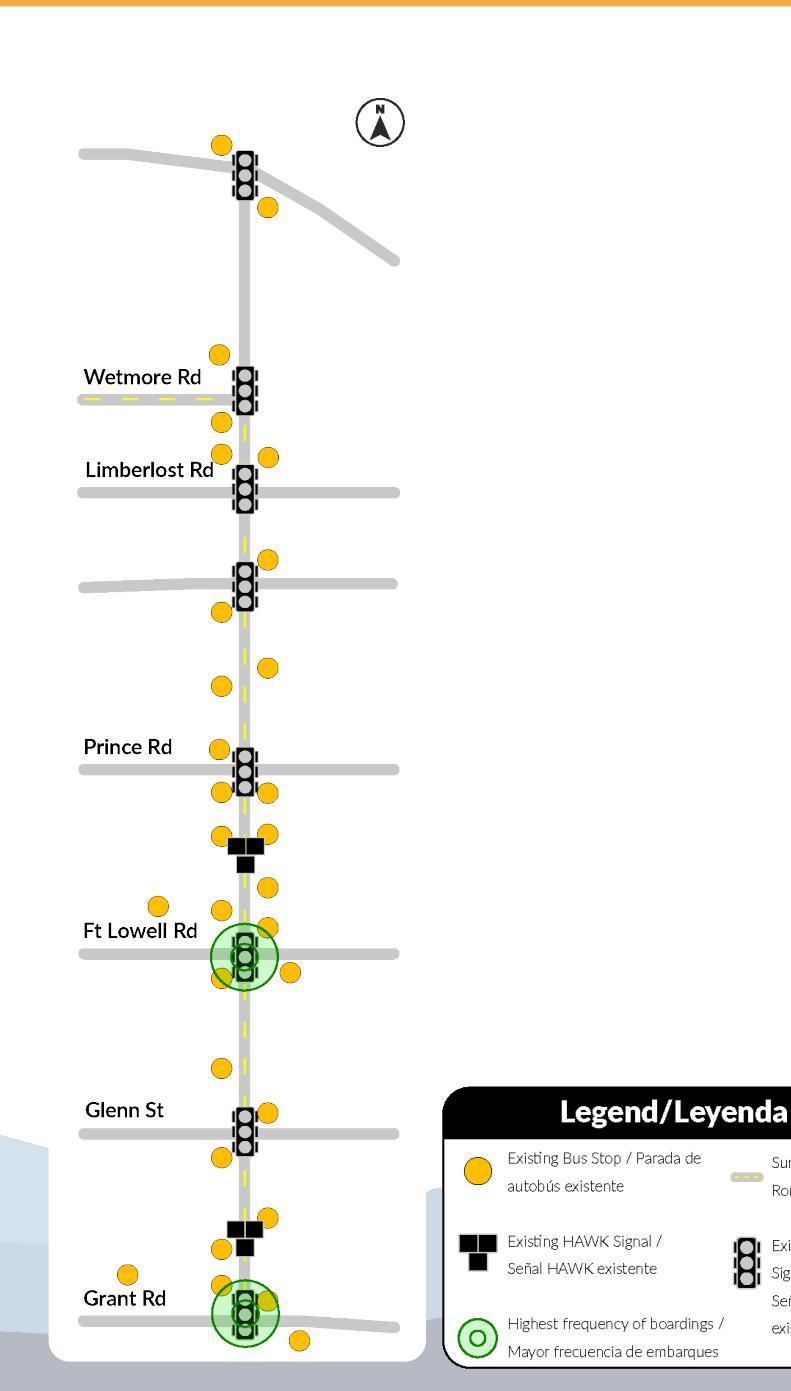
Current Conditions: Public Transit

- Most transit stops along 1st Avenue are close to a traffic signal or pedestrian crossing.
- Sun Tran Route 6 ranks 12th out of 62 routes for highest daily weekday boardings in the transit system.
- Sun Tran Route 6 has an estimated 1,924 daily, weekday boardings.
- Fort Lowell Road and Grant Road bus stops are the busiest.

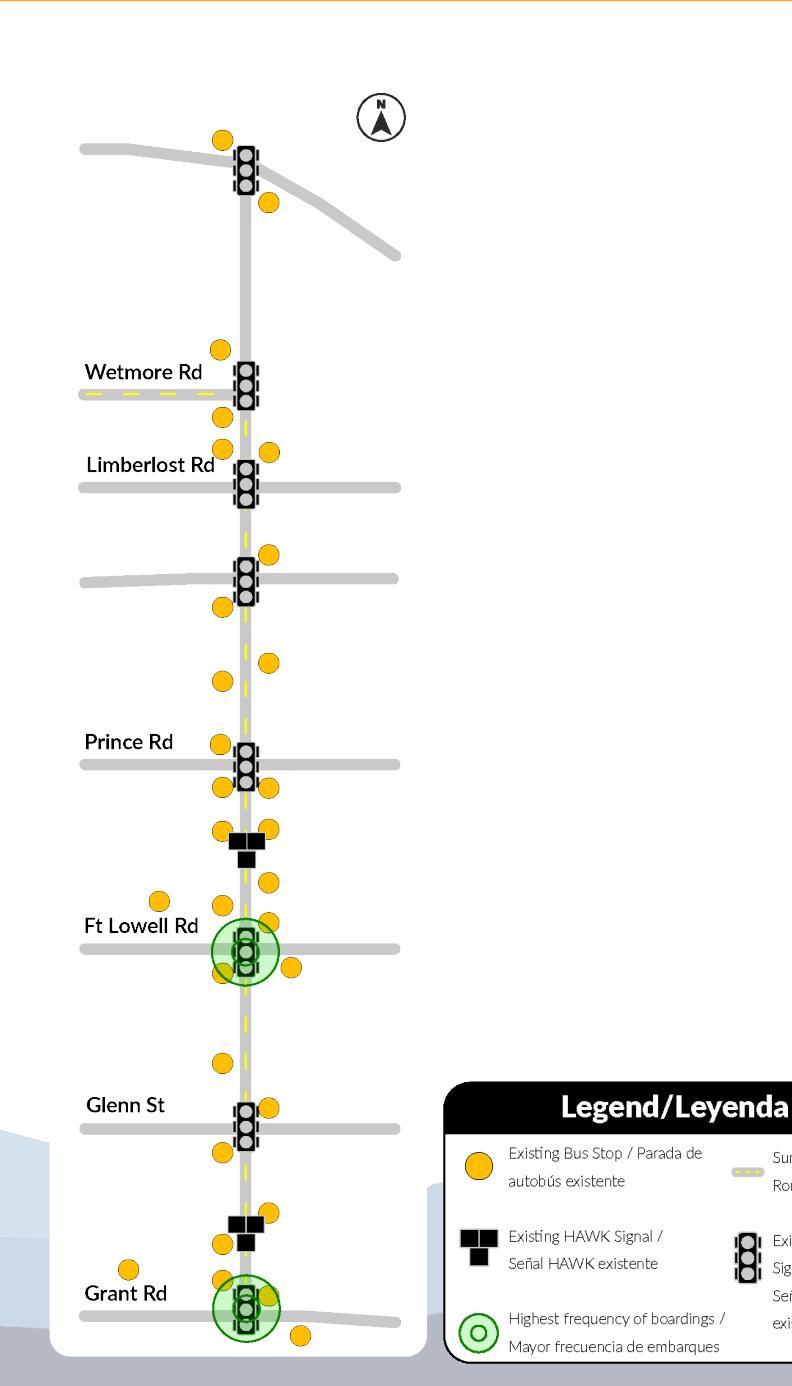
Current Conditions: Transit Operations

- 23 bus stops
- Crosswalks at 8 traffic signals
- 2 HAWK signals

- Northbound travel time from Grant Road to Wetmore Road ranges from 11 to 14 minutes
- Southbound travel time from Wetmore Road to Grant Road ranges from 10 to 11 minutes

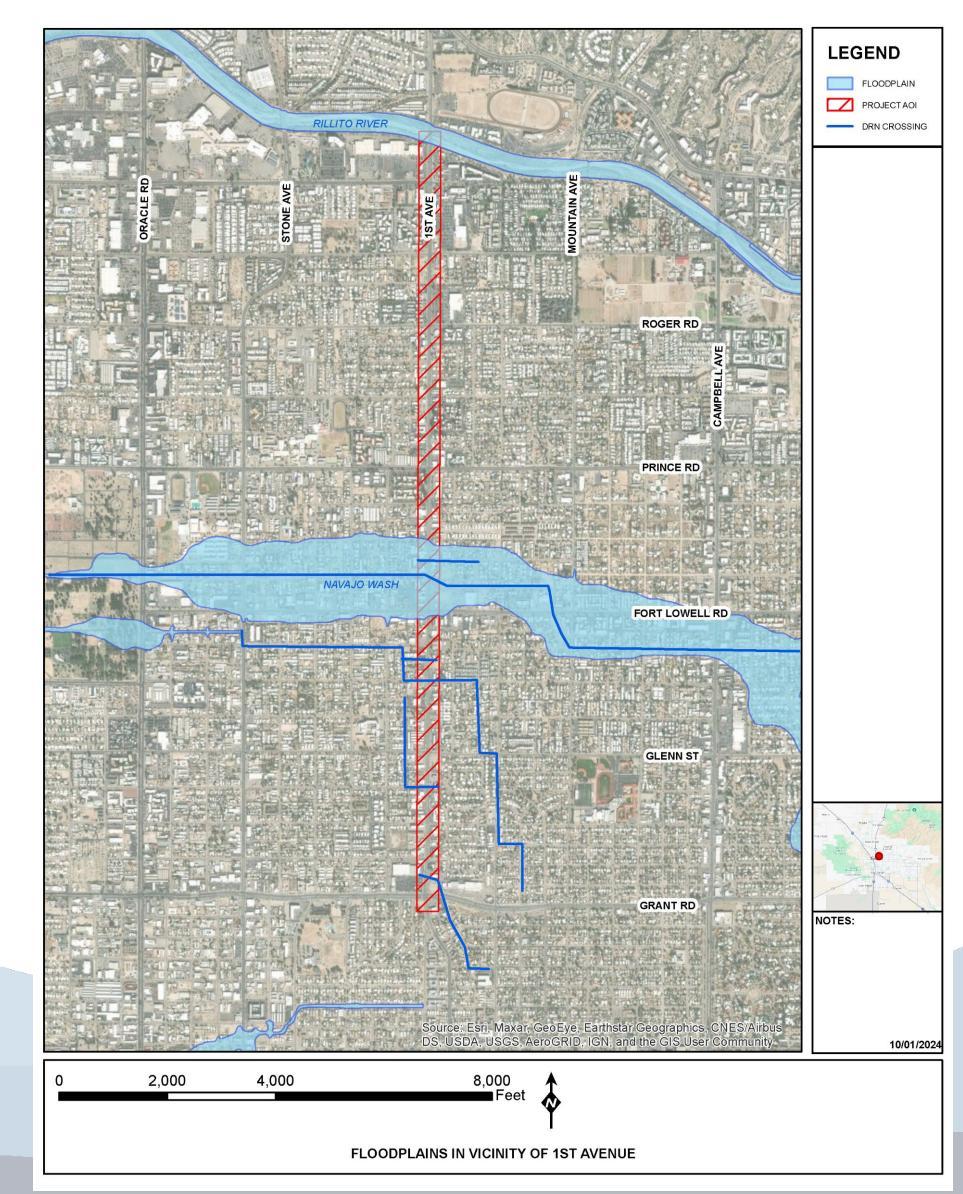
Current Conditions: Drainage

- There are six drainage crossings, including a major floodplain, within the project corridor.
- The limited capacity of the drainage system causes flooding and standing water in the corridor.
- Aged drainage infrastructure and outdated designs of the current drainage system can be updated along the corridor to improve its performance.
